Manhole Inspection Summary

Manhole # S47A1_006MH

Insp Date: **2/5/09 12:07 PM**

Location Address: **2025 mcomas st**

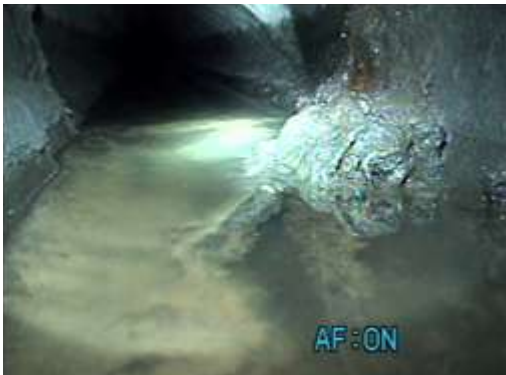
Misc

channel debris

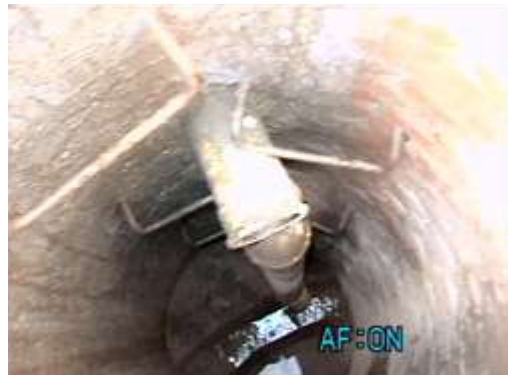
Misc.

top view of inside drop @ 11 O'clock.

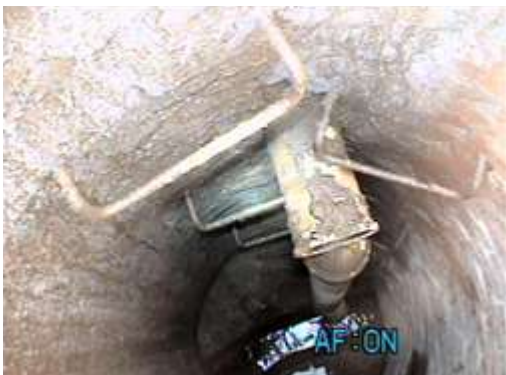
Defect 4

Count: **7** Missing: **0** ☒ **Corroded**

cor. steps

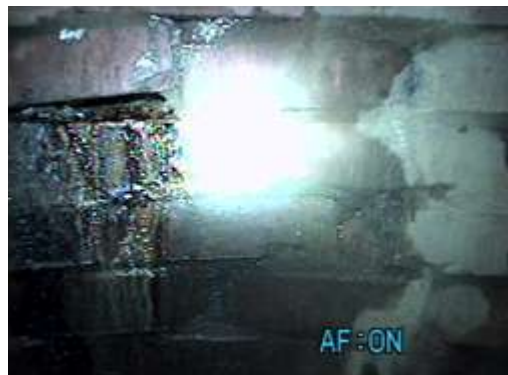
Defect 4

Infiltration: ☐ None ☐ Joint ☐ Cracks ☐ Mortar ☐ Roots ☒ **Wall**

infiltration in barrel

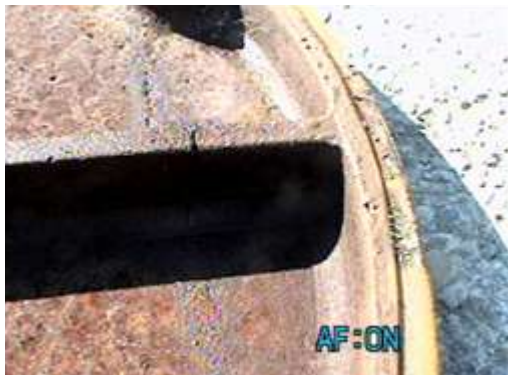
Defect 2

Condition: **Cracked**

crack cover
